COLUMBUS
STAINLESS
[Pty] Ltd

MEMORANDUM

To: P S Du Toit (TCS)
CC: **E-Block** **Lab**
N J Fourie D A A Smith
L Mashigo File
From: Kavith Nundlall (Metallurgical Services & Development)
Date: 29th May, 2018
Met. Ref. 201804M04
Subject: Final Report on the Salt Spray Testing comparative analysis of hot-dip galvanised carbon steel and 3CR12 stainless steel friction rock stabilizer split-sets ex Mpumatube
Keywords: Salt Spray Testing; hot-dip galvanised carbon steel; 3CR12; friction rock stabilizer split-sets; roof bolts; ASTM B117-97; Mpumatube

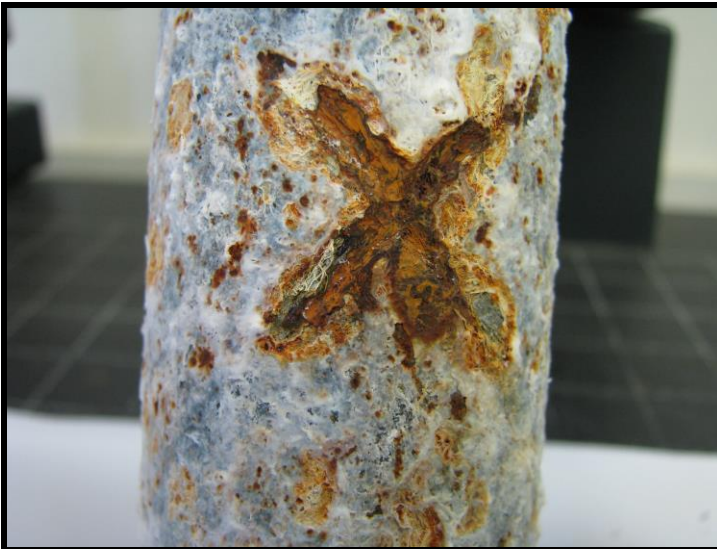
Photograph 11 showing the severe corrosion deposits present in the scribed section of Sample 1 after the 1000 hour exposure.

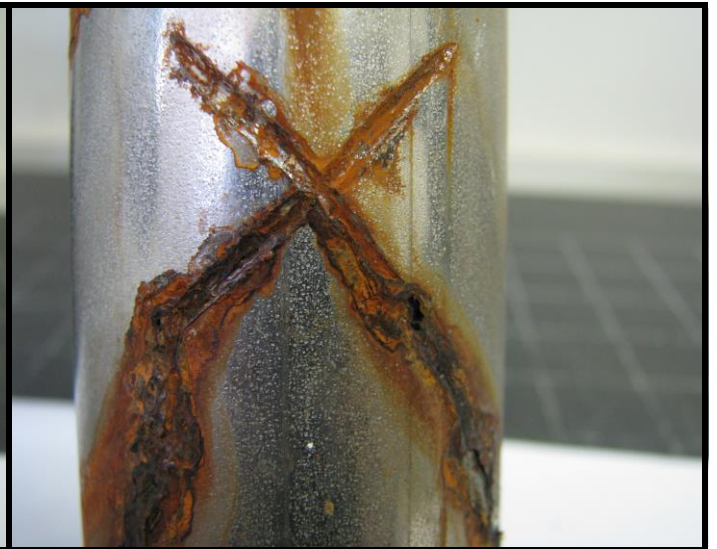
Photograph 12 showing a close-up of the corrosion and run-off staining in the scribed section of Sample 2 after the 1000 hour exposure.

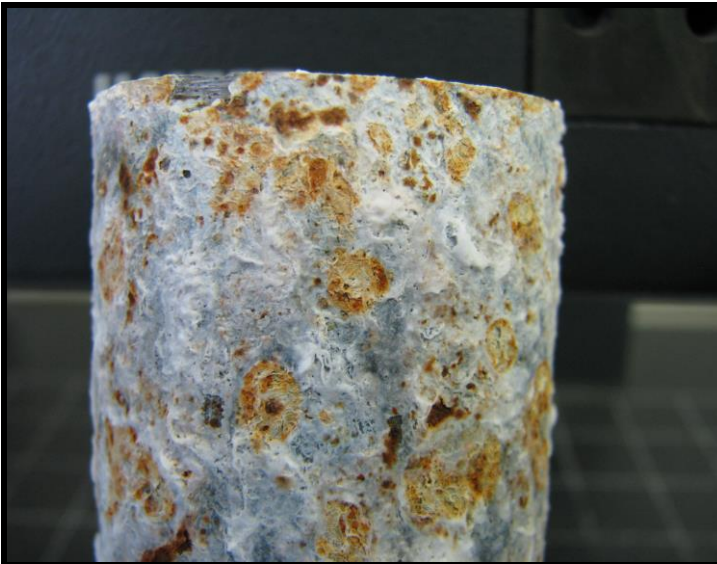
Photograph 13 showing the corrosion at the top section of Sample 1 after the 1000 hour exposure.

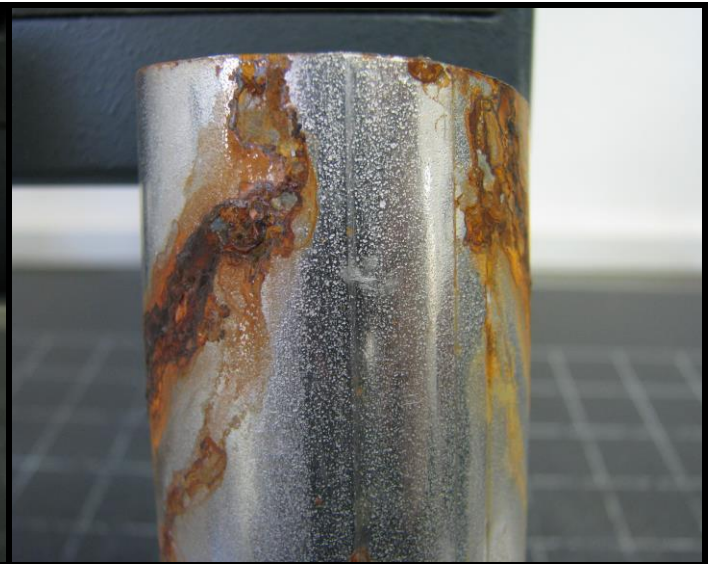
Photograph 14 showing the run-off staining at the top of Sample 2 after the 1000 hour exposure.

- After the 1008 hours of salt spray exposure (Week 6), the entire surface of Sample 1 was covered with the white corrosion product (consisting mainly of Zinc oxide) – see Photograph 10. The reddish brown corrosion product had increased significantly over the entire Sample 1 surface (see Photograph 10). The Sample 2 surface showed typical run-off staining with the absence of any pitting or general corrosion present (see Photograph 10). The close-up examination of the inscription on the Sample 1 surface revealed significant reddish brown corrosion product confirming that the metal had been severely attacked (see Photograph 11). Similarly, there was excessive run-off staining emanating from the Sample 2 inscription (see Photograph 12). The top and bottom Sample 1 surface exhibited significant reddish brown corrosion product over the entire surface confirming that the underlying metal was corroding (see Photographs 13 and 15). The run-off from the top and to the bottom of Sample 2 was quite excessive (see Photographs 14 and 16). The inner surfaces of both samples showed no major corrosive attack (see Photographs 17 and 18).

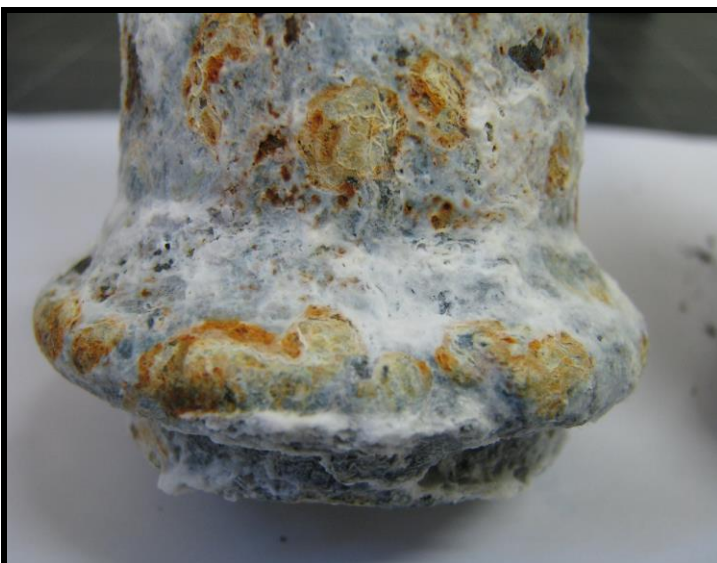
Photograph 15 showing the corrosion on the bottom section of Sample 1 after the 1000 hour exposure.

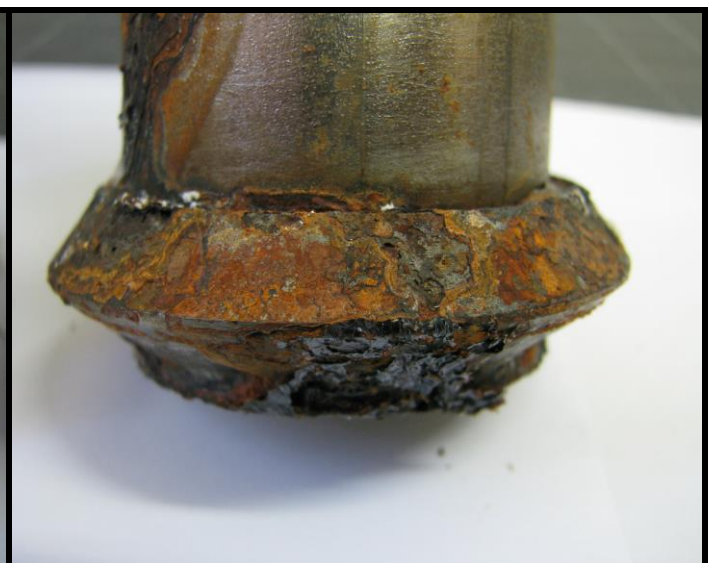
Photograph 16 showing the corrosion due to the run-off staining at the bottom section of Sample 2 after the 1000 hour exposure.

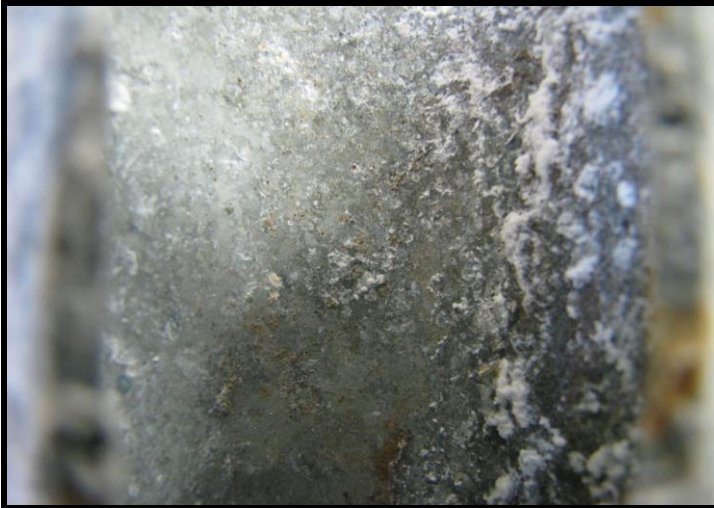
Photograph 17 showing the inner surface of Sample 1 after the 1000 hour exposure.

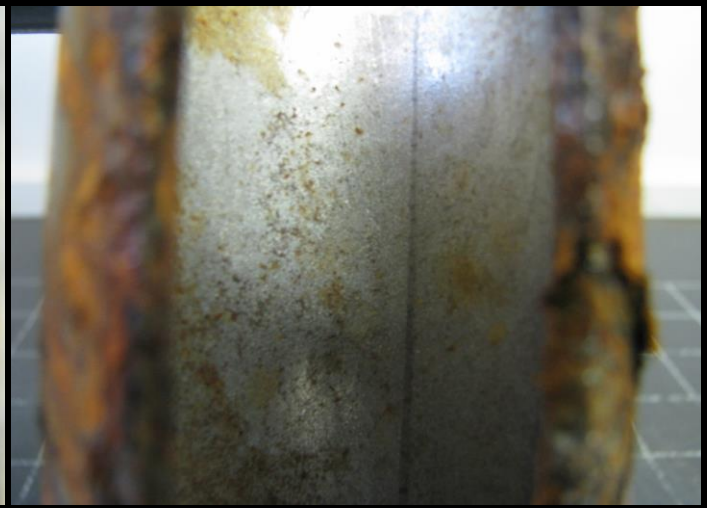
Photograph 18 showing the inner surface of Sample 2 after the 1000 hour exposure.

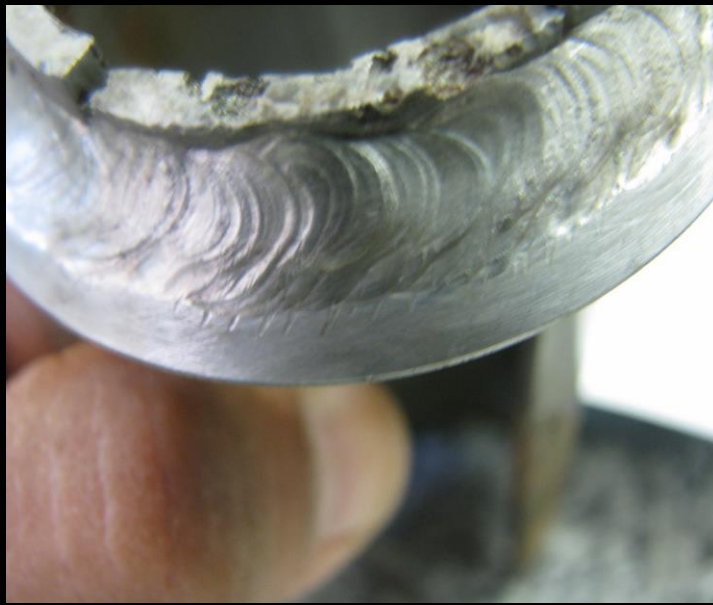
Photograph 19 showing the Sample 2 weld after mechanical and chemical cleansing.

The visual examination conducted on both the welds of Samples 1 and 2, revealed the absence of any pitting or other detrimental corrosion effects present in the welds, after performing both the mechanical and chemical cleansing. This confirmed that both the welds showed good integrity.

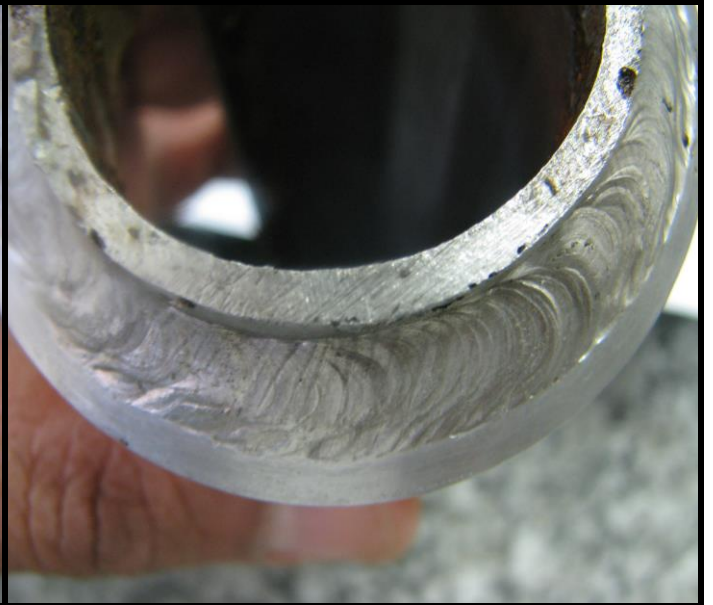
Photograph 20 showing another area of the Sample 2 weld after both mechanical and chemical cleansing.

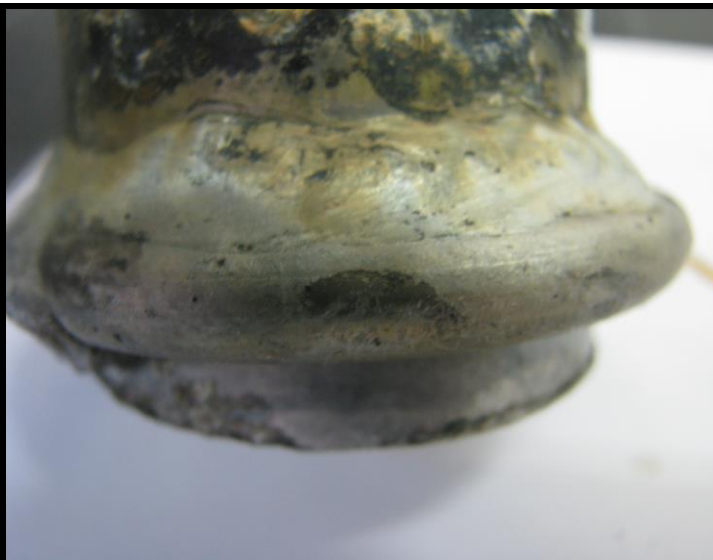
Photograph 21 showing the Sample 1 weld after mechanical and chemical cleansing.

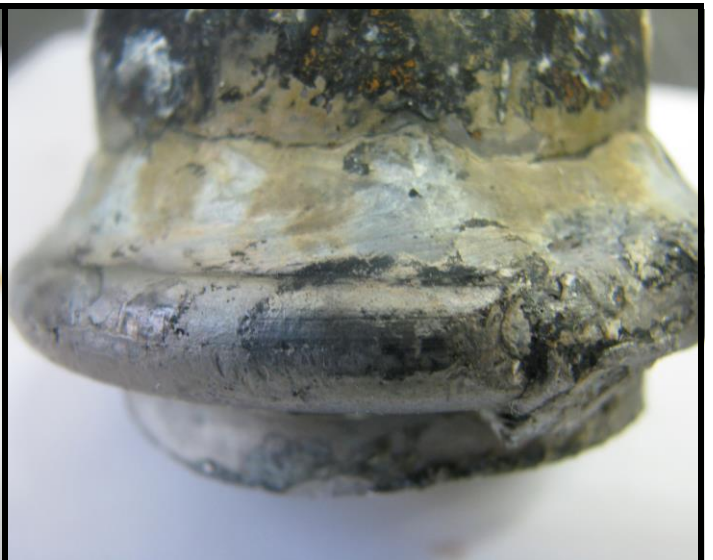
Photograph 22 showing another area of the Sample 1 weld after both mechanical and chemical cleansing.

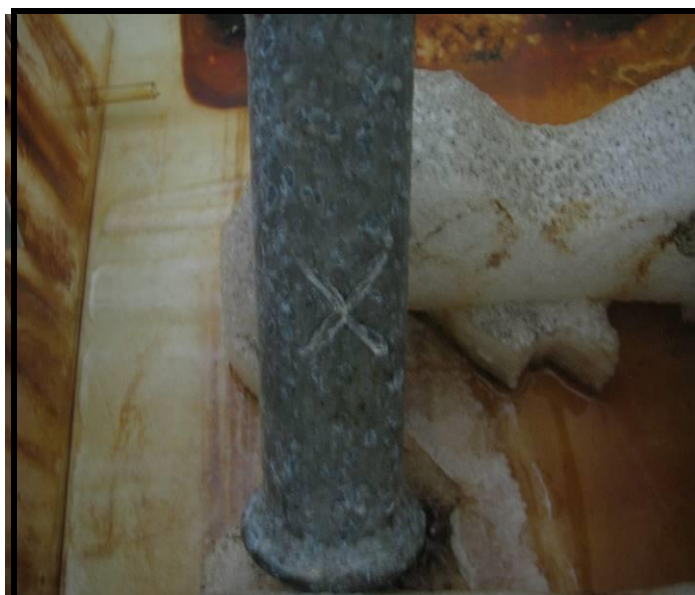
Photograph 23 showing the Sample 1 surface after 24 hours of continuous salt spray exposure.

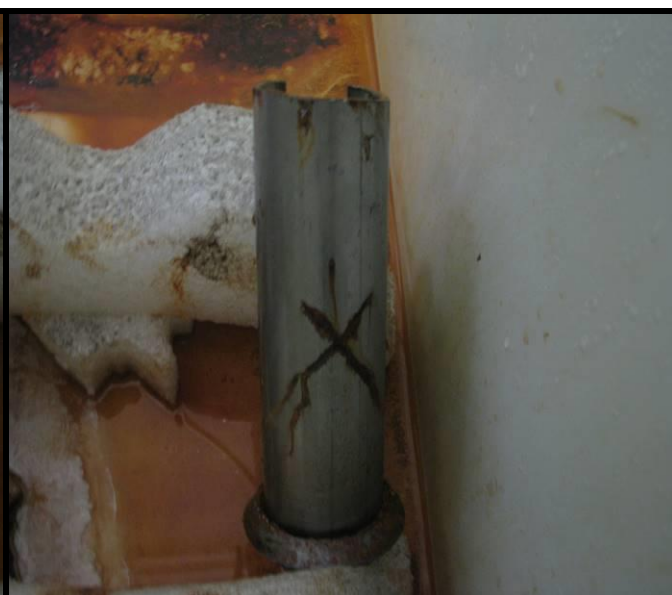
Photograph 24 showing the Sample 2 surface after 24 hours of continuous salt spray exposure.

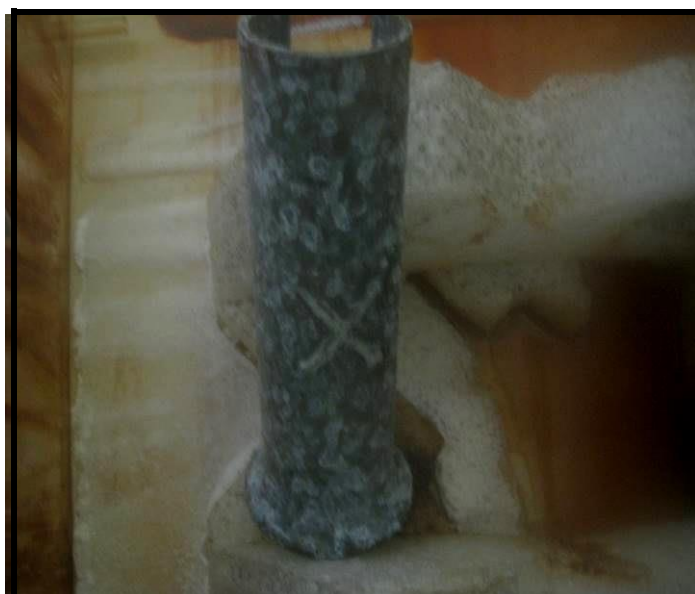
Photograph 25 showing the Sample 1 surface after 72 hours of continuous salt spray exposure.

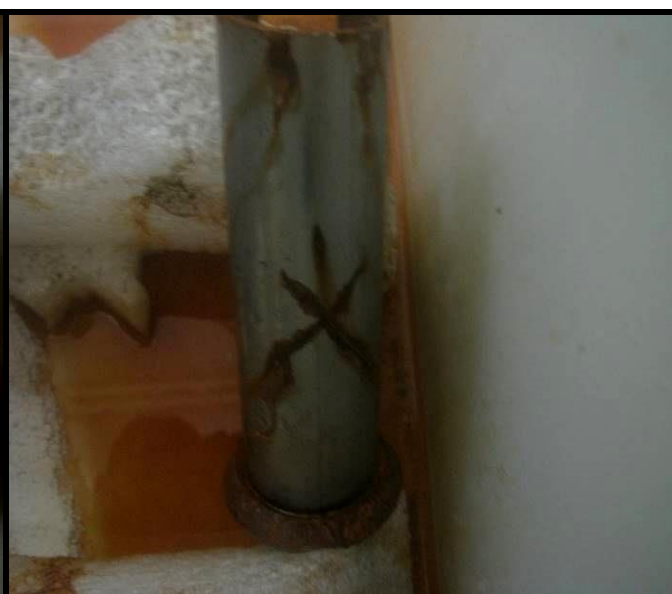
Photograph 26 showing the Sample 2 surface after 72 hours of continuous salt spray exposure.

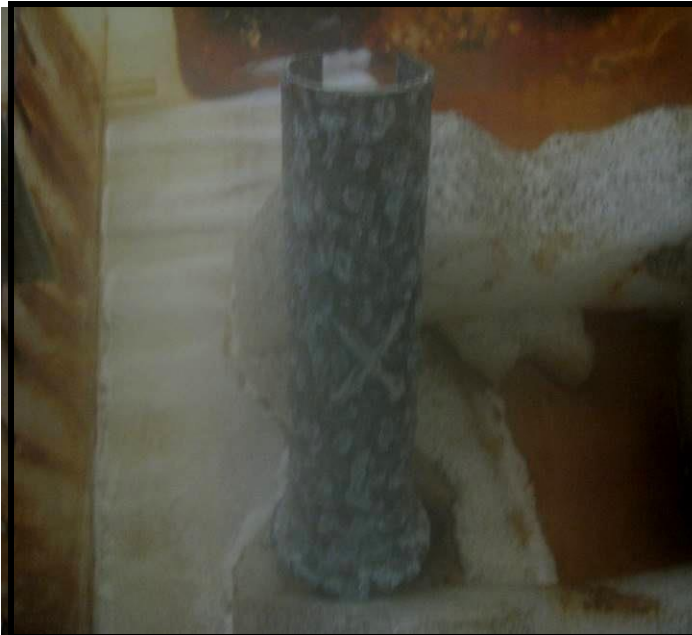
Photograph 27 showing the Sample 1 surface after 96 hours of continuous salt spray exposure.

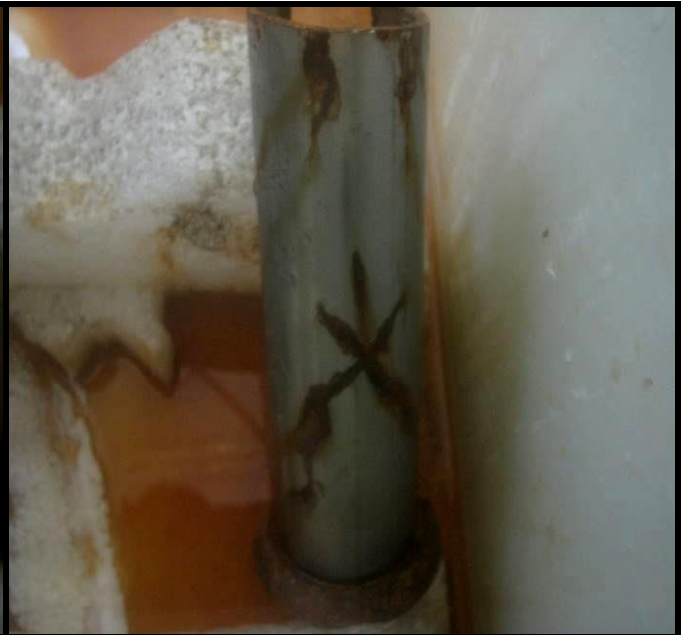
Photograph 28 showing the Sample 2 surface after 96 hours of continuous salt spray exposure.

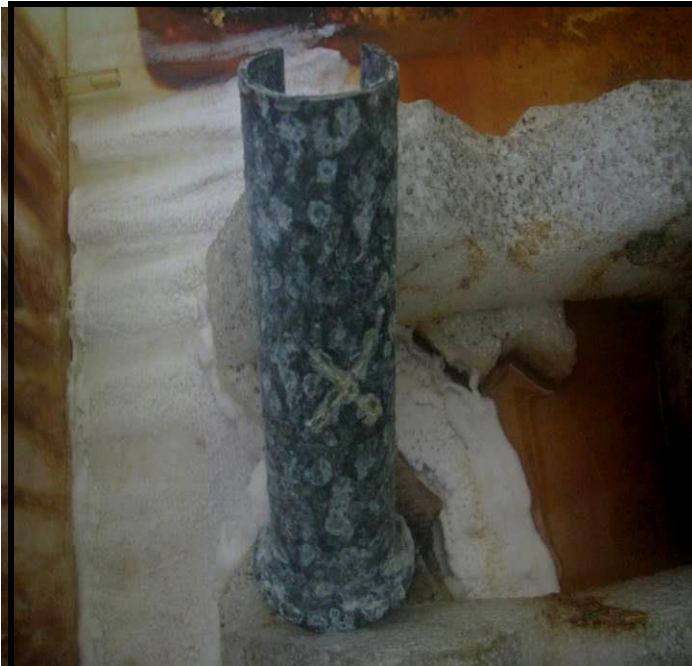
Photograph 29 showing the Sample 1 surface after 168 hours of continuous salt spray exposure.

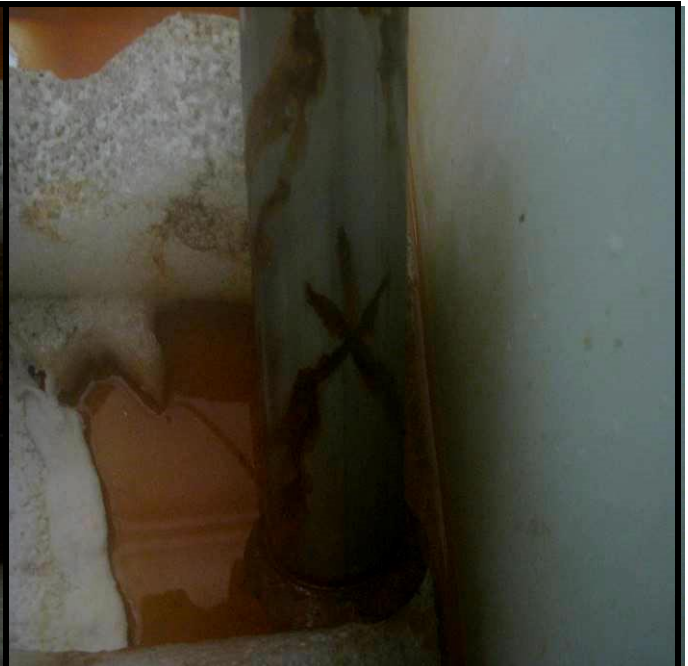
Photograph 30 showing the Sample 2 surface after 168 hours of continuous salt spray exposure.

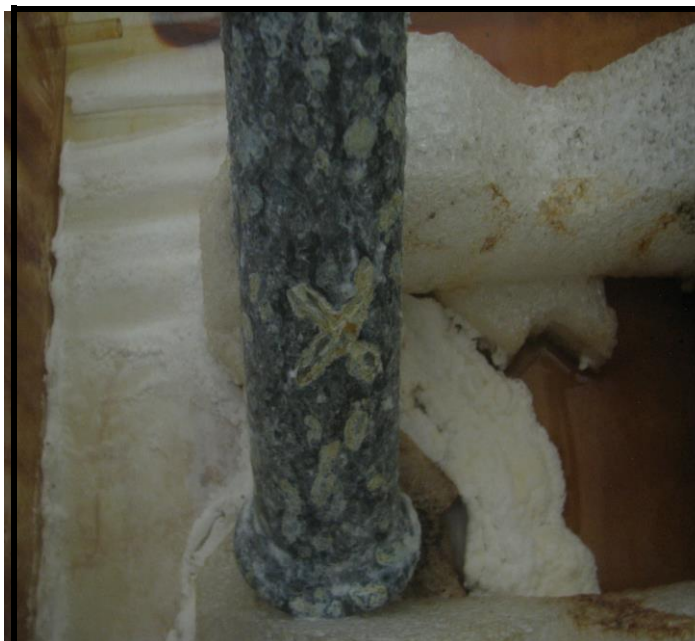
Photograph 31 showing the Sample 1 surface after 336 hours of continuous salt spray exposure.

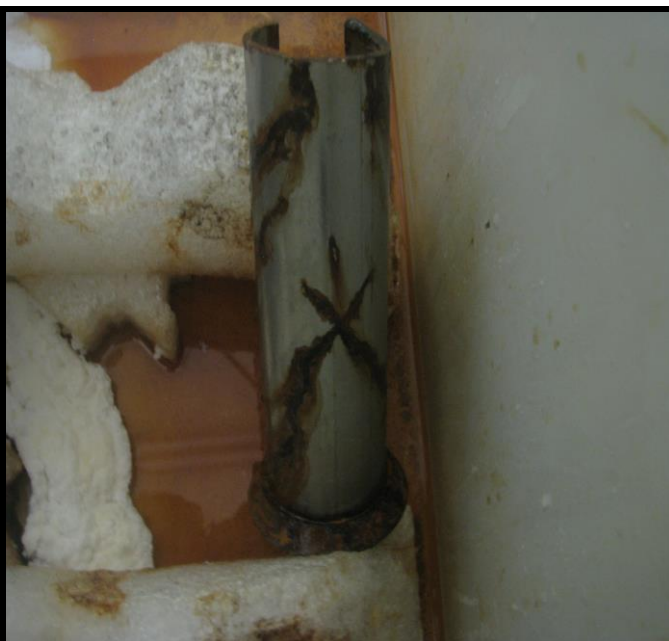
Photograph 32 showing the Sample 2 surface after 336 hours of continuous salt spray exposure.

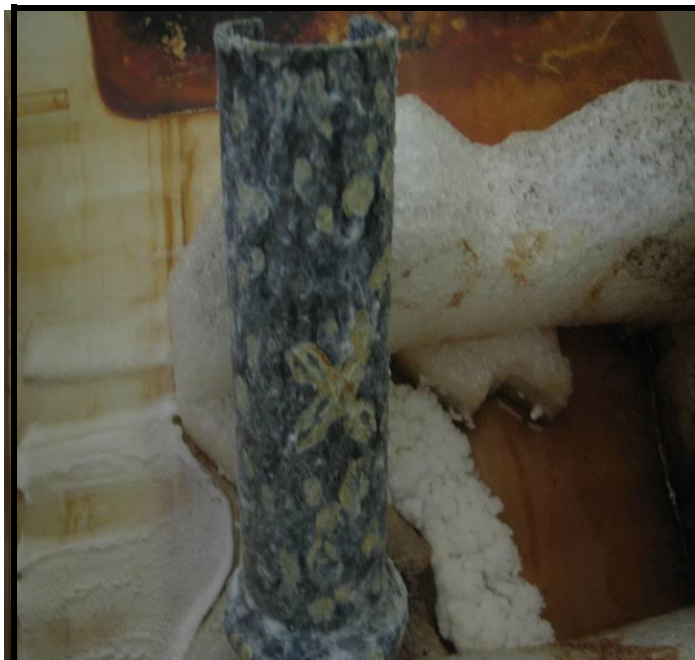
Photograph 33 showing the Sample 1 surface after 504 hours of continuous salt spray exposure.

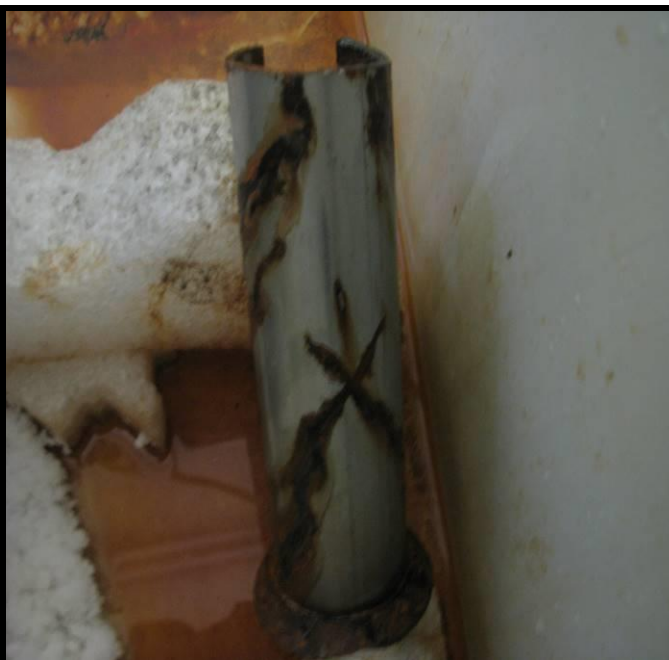
Photograph 34 showing the Sample 2 surface after 504 hours of continuous salt spray exposure.

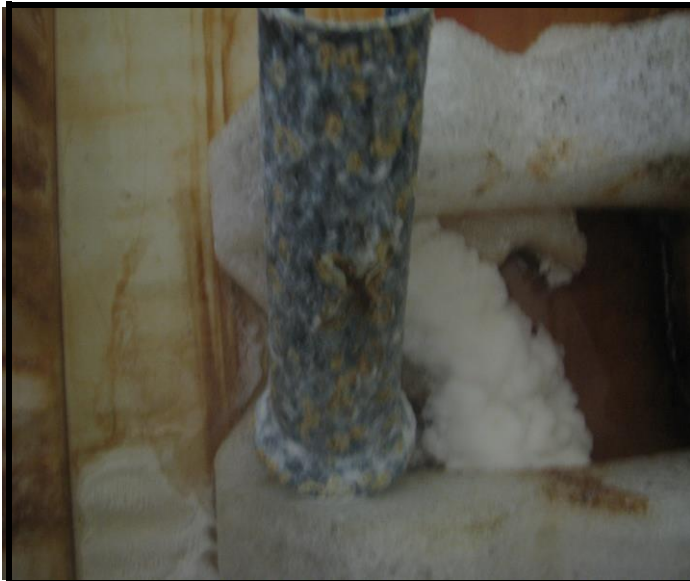
Photograph 35 showing the Sample 1 surface after 672 hours of continuous salt spray exposure.

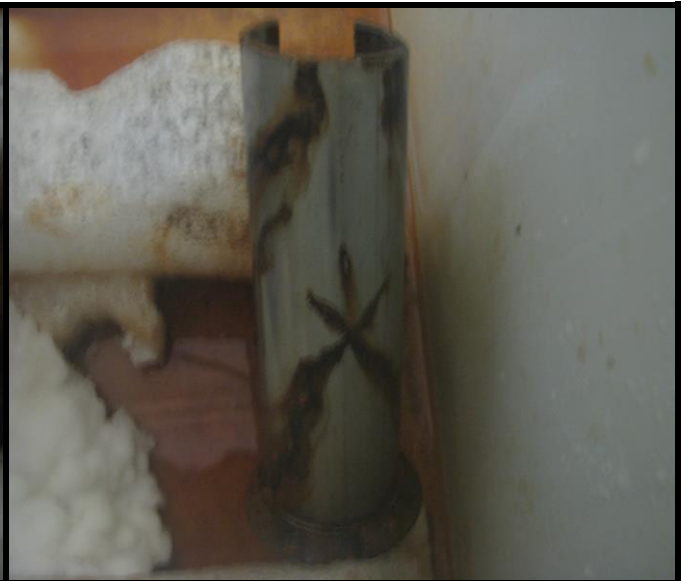
Photograph 36 showing the Sample 2 surface after 672 hours of continuous salt spray exposure.

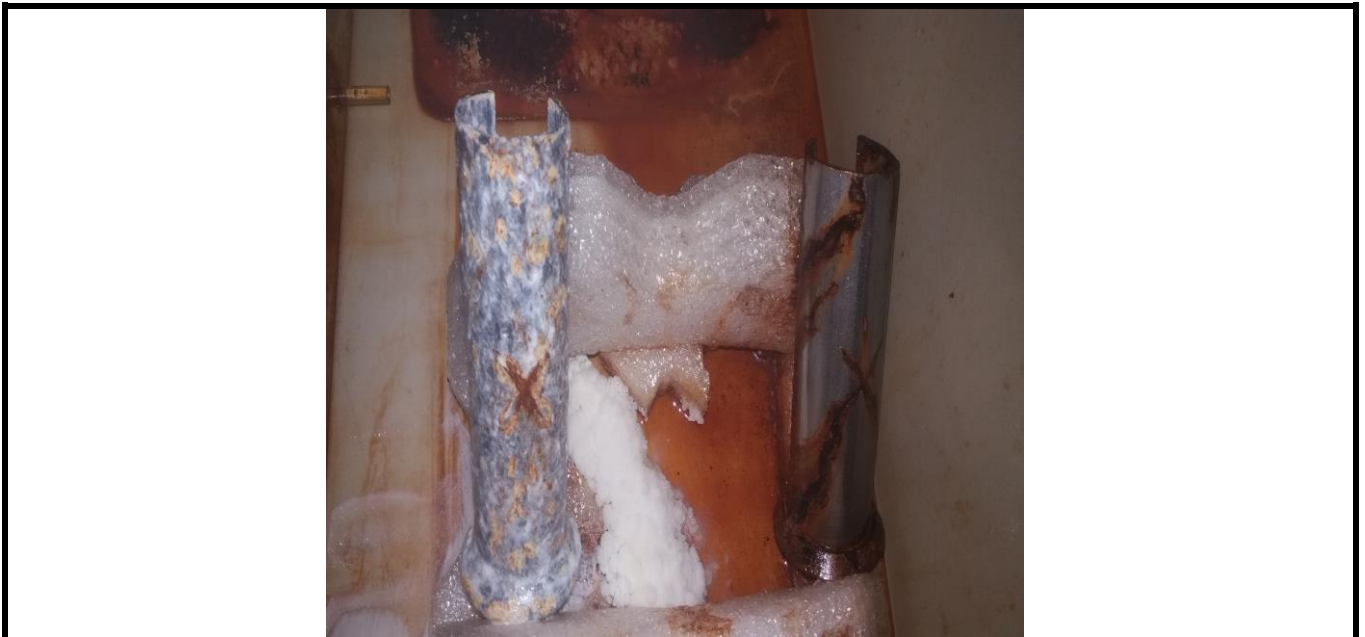
Photograph 37 showing the Sample 1 and Sample 2 surface after 840 hours of continuous salt spray exposure.

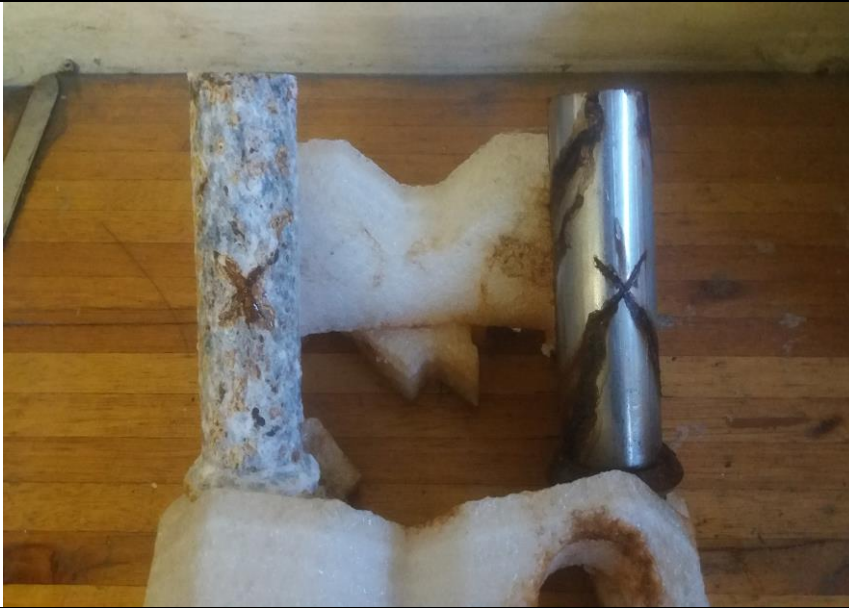
Photograph 38 showing the Sample 1 and Sample 2 surface after the 1008 hours of continuous salt spray exposure.
