COLUMBUS
STAINLESS
[Pty] Ltd

MEMORANDUM

To: P S Du Toit (TCS)
CC: **E-Block** **Lab**
N J Fourie D A A Smith
L Mashigo File
From: Kavith Nundlall (Metallurgical Services & Development)
Date: 29th May, 2018
Met. Ref. 201804M04
Subject: Final Report on the Salt Spray Testing comparative analysis of hot-dip galvanised carbon steel and 3CR12 stainless steel friction rock stabilizer split-sets ex Mpumatube
Keywords: Salt Spray Testing; hot-dip galvanised carbon steel; 3CR12; friction rock stabilizer split-sets; roof bolts; ASTM B117-97; Mpumatube

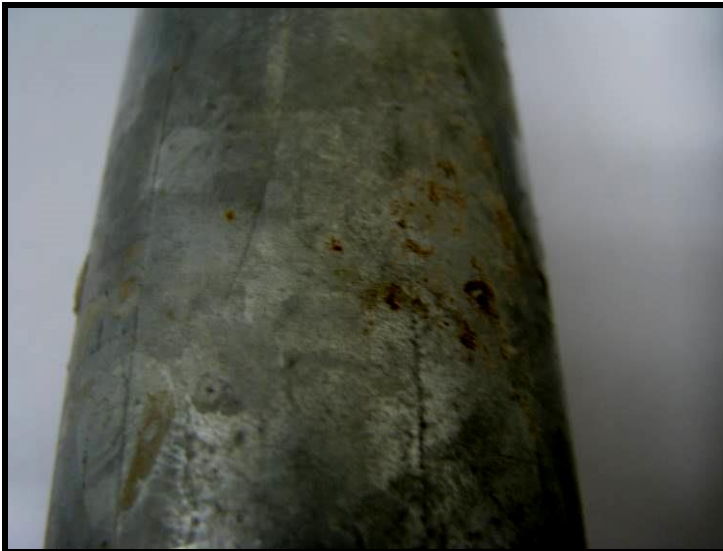
Photograph 4 showing a close-up of the Sample 1 surface.

The visual examination of the friction rock stabiliser split-set revealed that the submitted Sample 1 had some minor damage to the galvanising on the surface (see Photograph 4 - this would have most likely occurred during the insertion of the sample during operation). There were also a few minor scratches on the Sample 2 surface, but this would not have significantly influenced the corrosion rate. The tubes were of similar gauge.

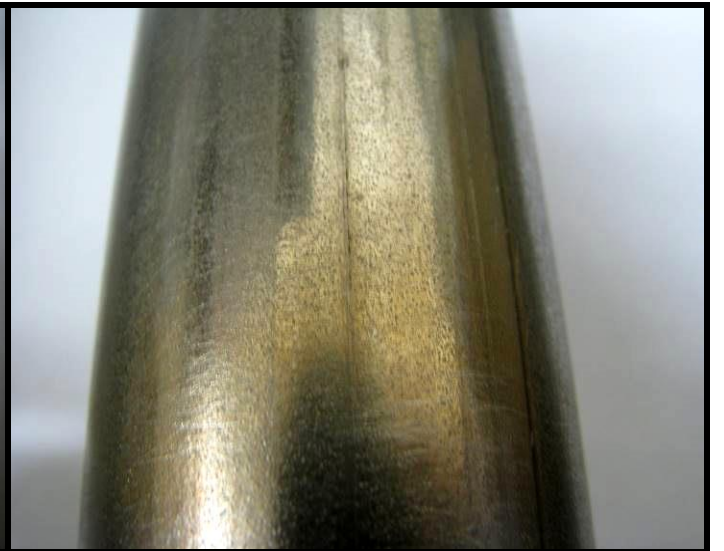
Photograph 5 showing a close-up of the Sample 2 surface.

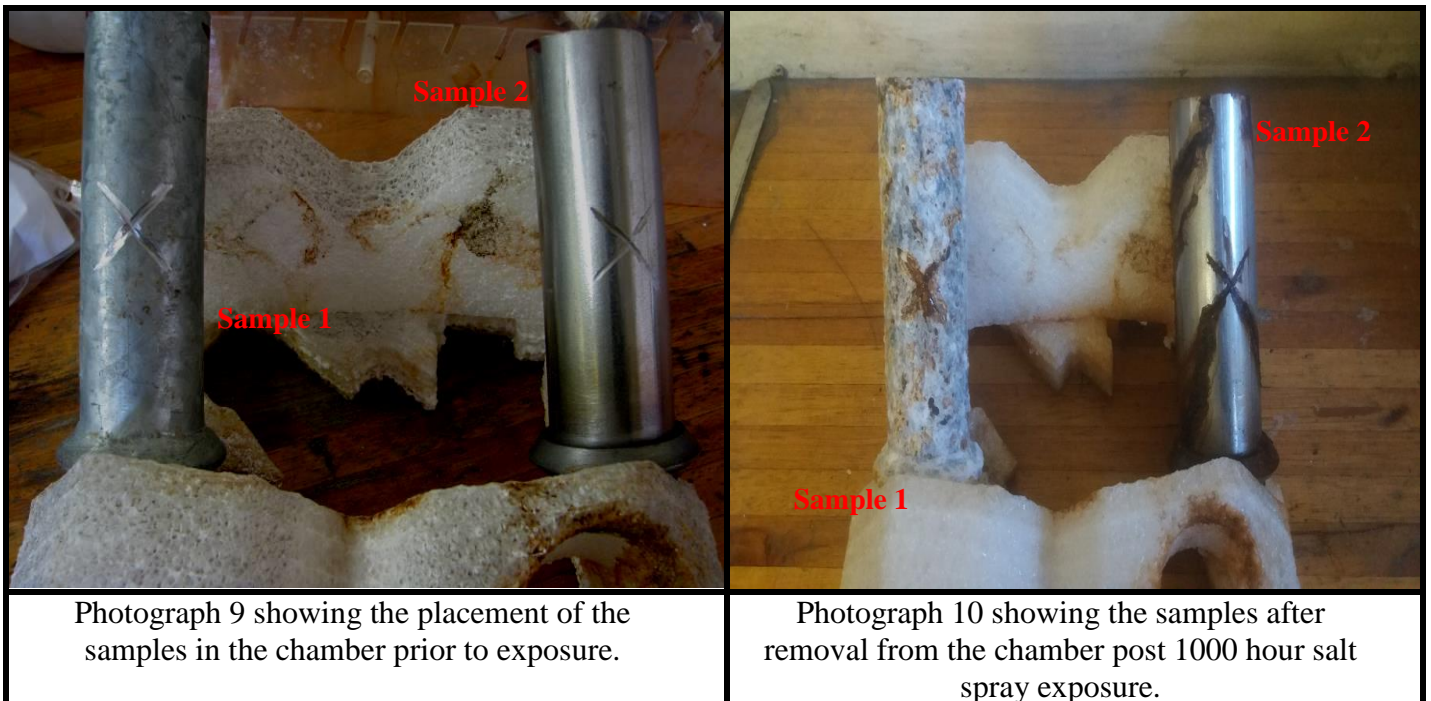
- After the 1008 hours of salt spray exposure (Week 6), the entire surface of Sample 1 was covered with the white corrosion product (consisting mainly of Zinc oxide) – see Photograph 10. The reddish brown corrosion product had increased significantly over the entire Sample 1 surface (see Photograph 10). The Sample 2 surface showed typical run-off staining with the absence of any pitting or general corrosion present (see Photograph 10). The close-up examination of the inscription on the Sample 1 surface revealed significant reddish brown corrosion product confirming that the metal had been severely attacked (see Photograph 11). Similarly, there was excessive run-off staining emanating from the Sample 2 inscription (see Photograph 12). The top and bottom Sample 1 surface exhibited significant reddish brown corrosion product over the entire surface confirming that the underlying metal was corroding (see Photographs 13 and 15). The run-off from the top and to the bottom of Sample 2 was quite excessive (see Photographs 14 and 16). The inner surfaces of both samples showed no major corrosive attack (see Photographs 17 and 18).
